# *Orange Beach High-Rise Study*

## **Post-Ivan High-Rise Damage Survey**

High-rise buildings along the Orange Beach, Alabama, Gulf of Mexico shoreline (seaward of Perdido Beach Boulevard.) were inspected by FEMA contractors between November 3 and 18, 2004. The purpose of the inspections was to determine the numbers and elevations of lowest floor living units that were damaged or destroyed by flood effects during Hurricane Ivan. Given the large number of damaged multi-family buildings that would not be classified as substantially damaged, an attempt was made to identify those lowest floor living units that could be repaired or reconstructed in-place, and which would have been classified as substantially damaged had they been individual buildings.

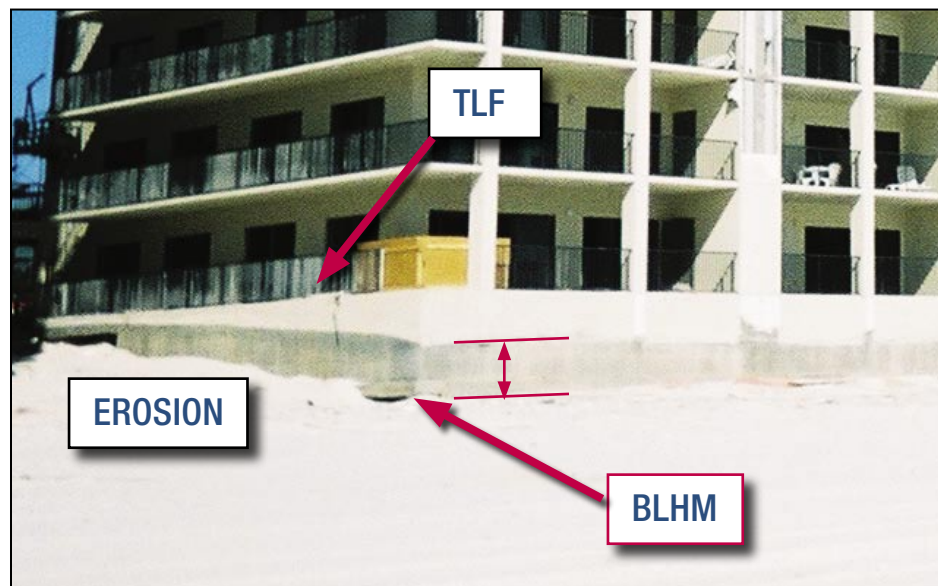
Figure F-5.  
Floor intact, wall intact  
damage state

- 13 percent of the buildings and 12 percent of the lowest floor living units sustained no damage whatsoever (floor intact, walls intact). See Figure F-5.

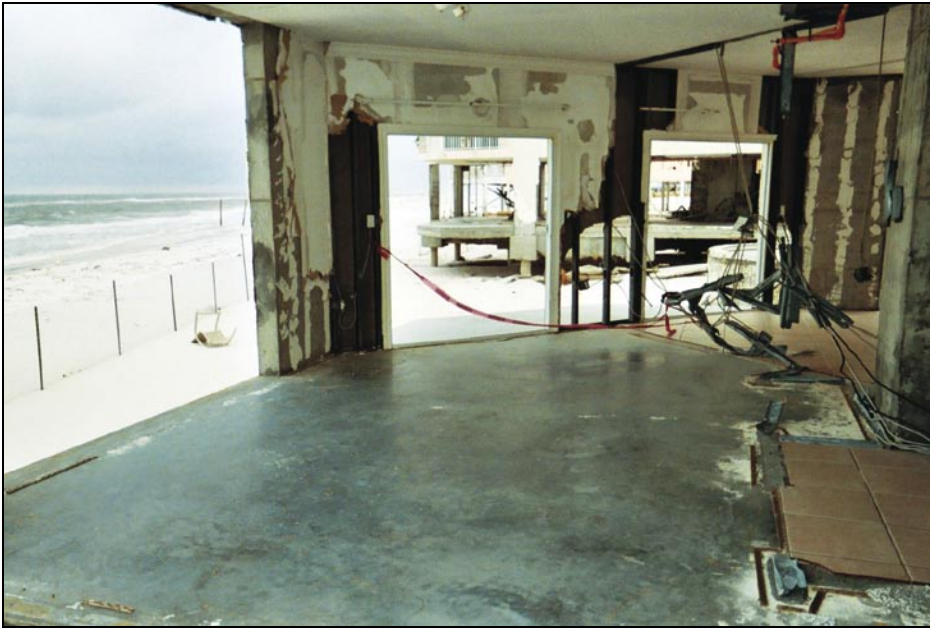
Figure F-6.  
Floor intact, wall  
destroyed damage state

- The most common lowest floor living unit damage state encountered was “floor intact, walls destroyed,” occurring in 44 percent of the buildings and 43 percent of the lowest floor living units. See Figure F-6.
- 31 percent of the buildings and 25 percent of the lowest floor living units sustained complete lowest floor destruction (floor destroyed, walls destroyed). See Figure F-7.
- 183 (79 percent) of the lowest floor living units sustained wall destruction (across all floor damage states). These units would likely have been classified as substantially damaged had they been individual buildings instead of units of high-rise structures.

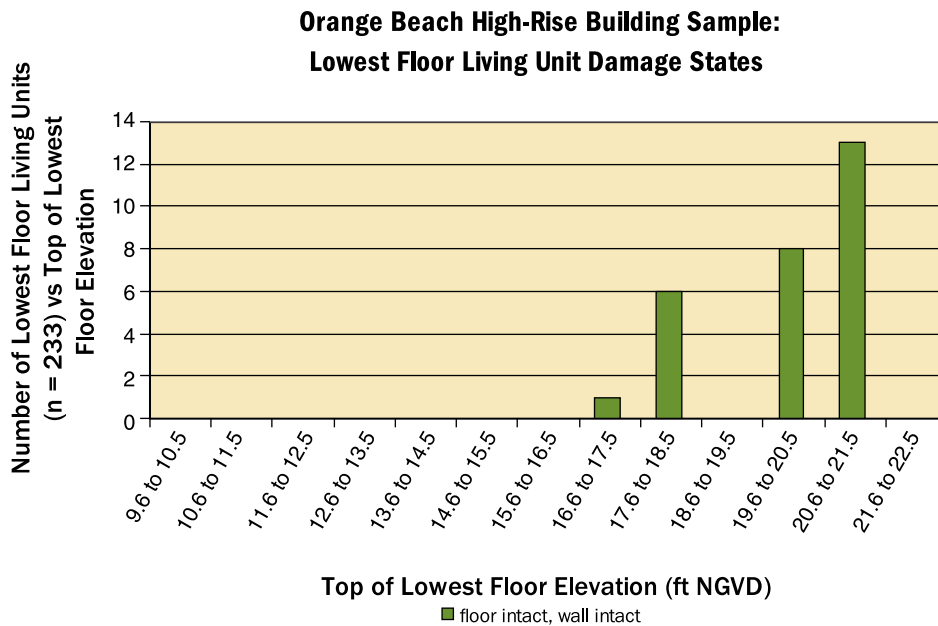
Figure F-8.  
Floor intact, wall intact  
damage state versus top  
of lowest floor elevation

Building damage states were compared against lowest floor elevations. Not surprisingly, buildings with the lowest floor elevations had more wall and floor destruction than buildings with higher floor elevations (see Table F-5, Figure F-8 and Figure F-9).

Note that even though the number of lowest floor living units above elevation 19.6 feet was less than 10 percent of the total number of lowest floor living units (see Figure F-4), these units accounted for 75 percent of the total number of undamaged lowest floor living units – units at higher floor elevations had a better survival rate.

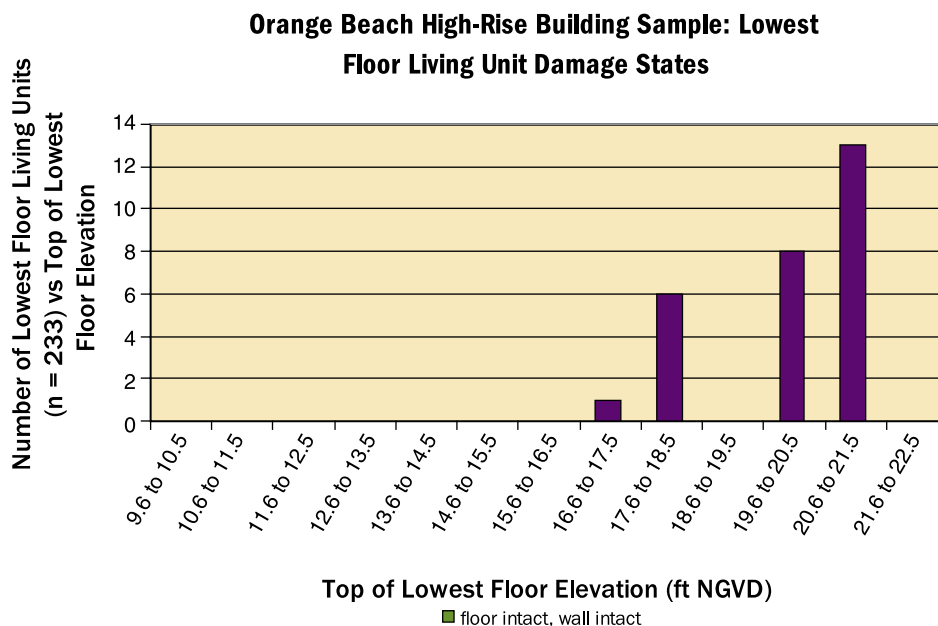
Figure F-9.  
Floor destroyed, wall  
destroyed damage state  
versus top of lowest floor  
elevation

Similarly, 69 percent of the totally destroyed lowest floor living units were below elevation 16.5 feet NGVD, even though only 52 percent of the total number of lowest floor living units were below this elevation – units at lower elevations had a greater likelihood of being destroyed.

- Elevating the lowest floor one story above the BFE and using the space below the BFE for parking would be the most appropriate means of reducing lowest floor living unit damage to new high-rise buildings in the area.
